**Oxford Historic Preservation Commission**

**COA application:** 149

**Address:** 631 Van Buren Avenue

**COA Request:** Request for Demolition under Section 54-31 "Public Safety Exclusion"

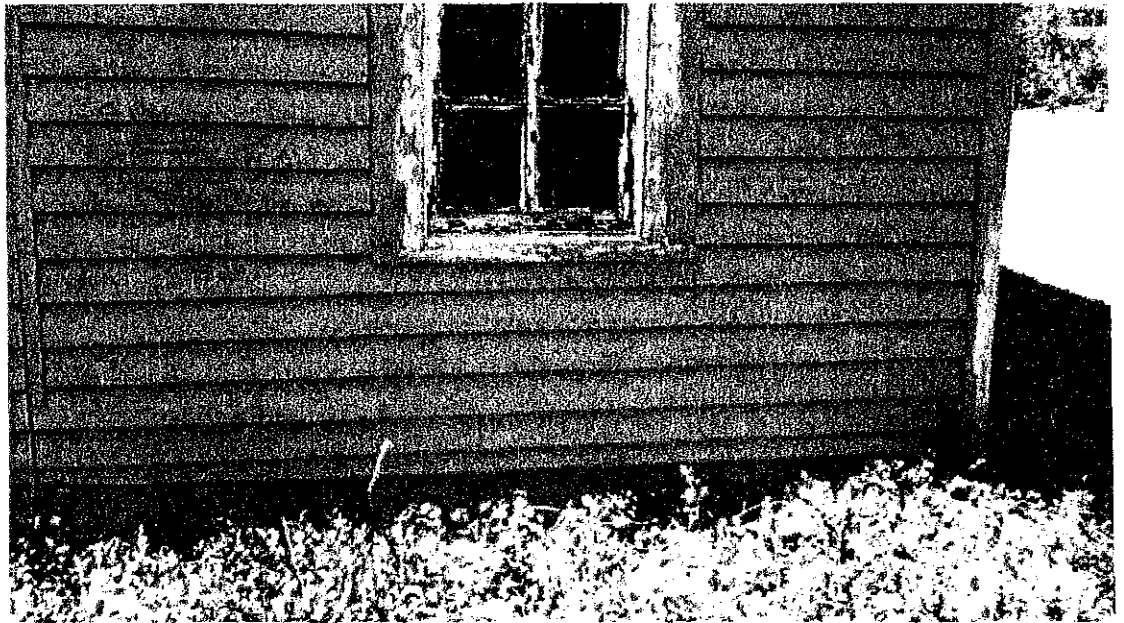
Photo 3

At what was likely a much later date an addition was constructed at the right rear of the house on a concrete block and slab foundation. (Photos 2 & 3) There had apparently been modifications to the rear porch and at the left rear of the house.

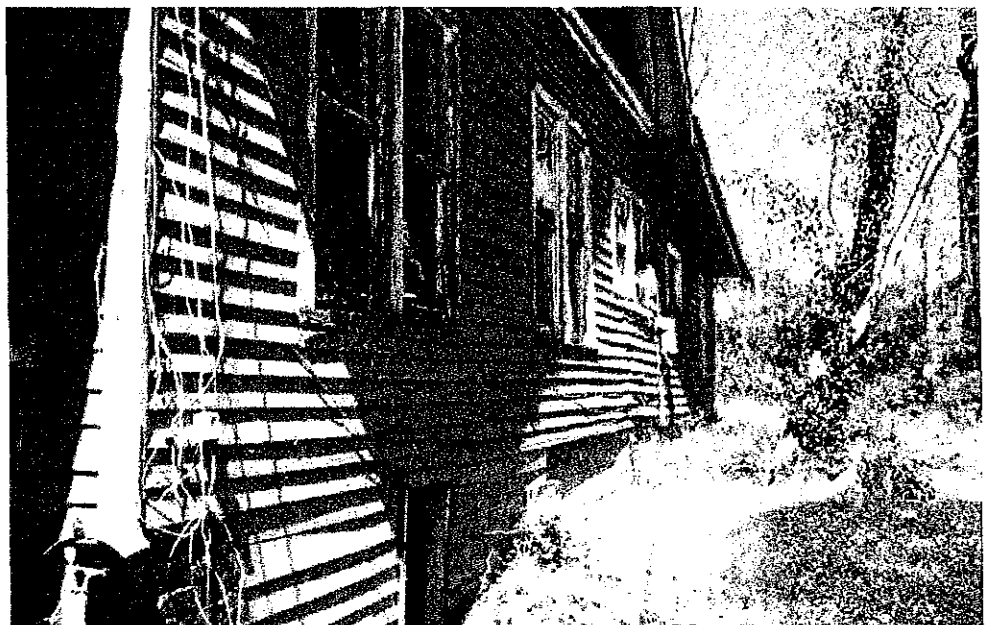
Photo 10

- 2) The right wall of the house was leaning out. This appeared to be at least partially due to the failure of the brick piers. (Photo 9)
- 3) Wood stud walls enclosed the crawl space at the right front of the house. This framing appeared to be constructed in contact with the ground. (Photo 10)

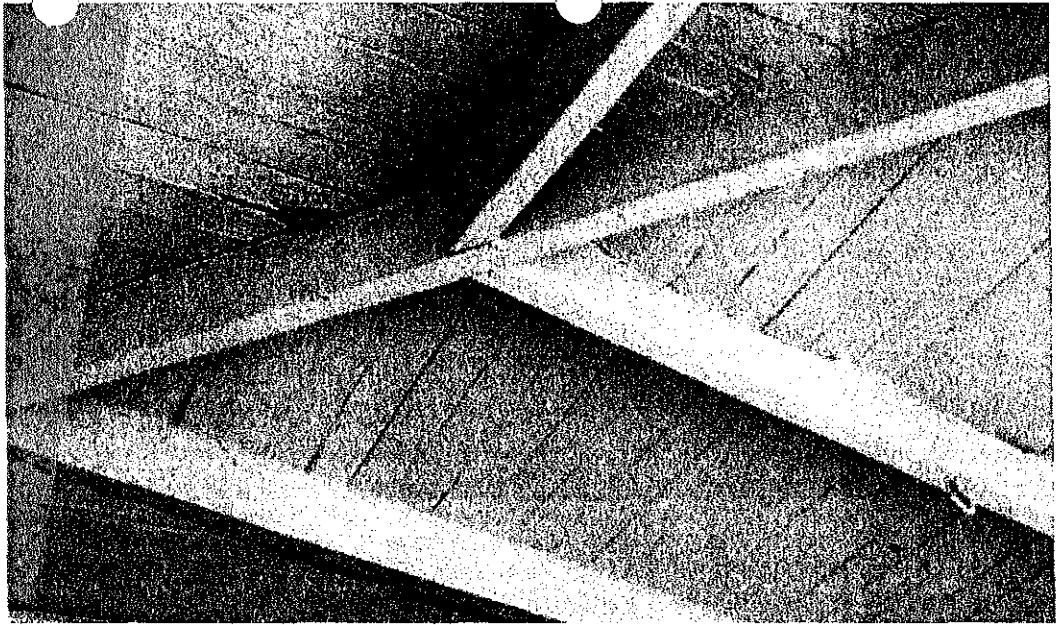
Photo 14

- 5) Porch ceiling had recently been painted. The new paint appeared to have covered deterioration of the wood. (Photo 13)
- 6) Wood beams at the front porch had noticeable sagging. (Photo 14)

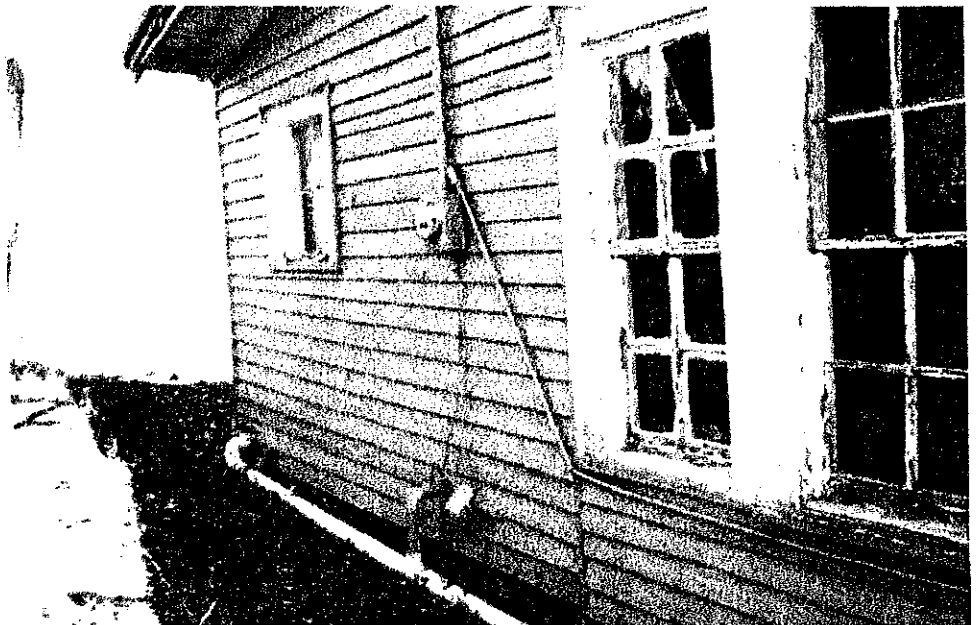
F. Jto 19

Although not a structural issue, drain lines from this area were run on the surface of the ground along the left side of the house. (Photos 18 & 19) Drains had no protection to prevent breakage of the lines.

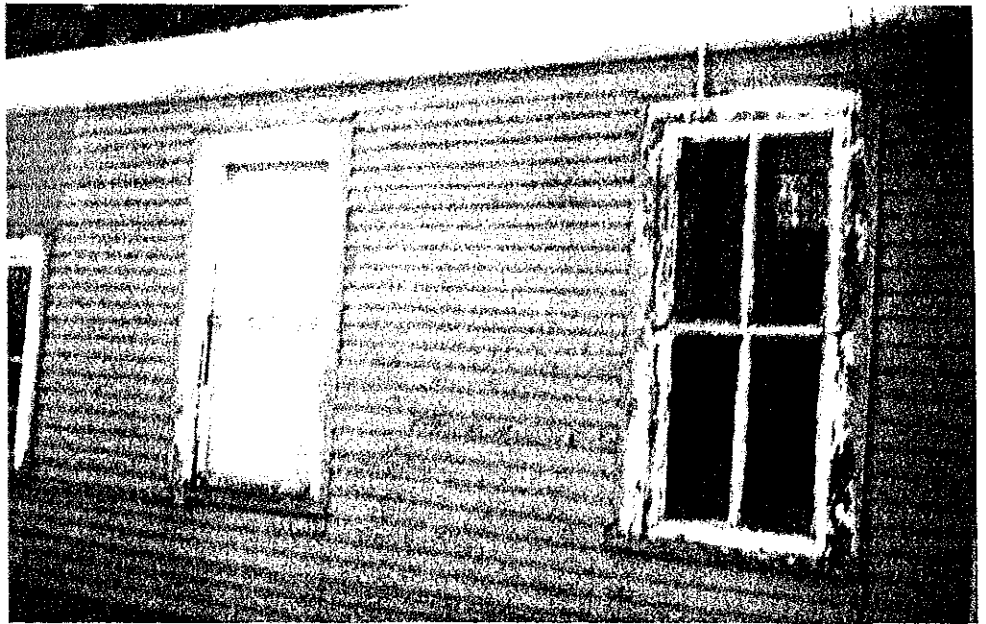
- 10) There was damage to wood window frames and trim around the house due to a long term lack of maintenance. It could not be determined whether there was damage to the wall framing. (Photo 20)
